Arthroscopy / MRI Correlation Conference

Department of Radiology, Section of MSK Imaging

Department of Orthopedic Surgery

Case 1: 29 YOM with recurrent shoulder dislocations

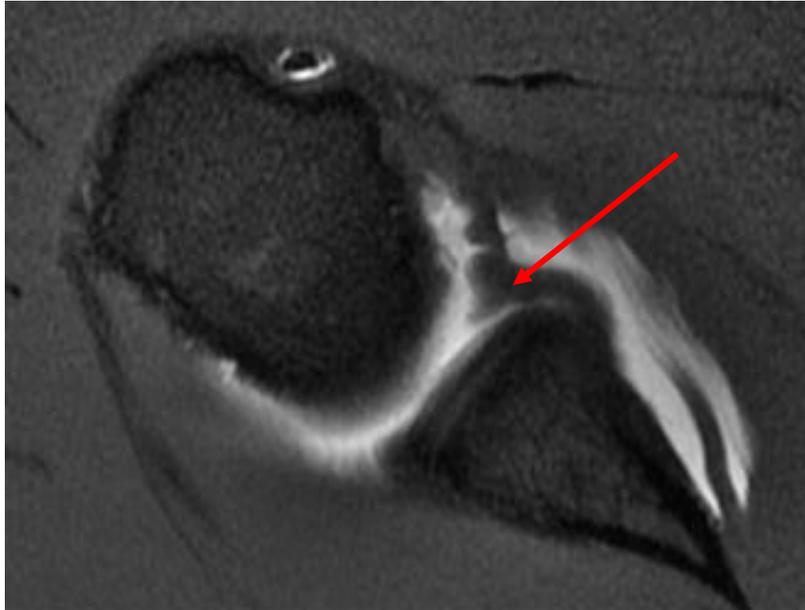
Axial T1FS MR arthrogram shows tear of the anterior inferior labrum which remains attached to torn and medially stripped periosteum of the scapula (anterior labroligamentous periosteal sleeve avulsion AKA ALPSA lesion)

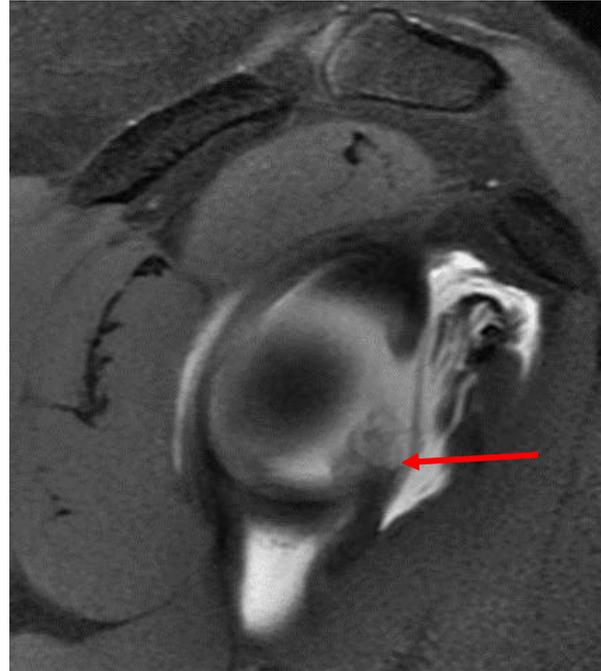
Sagittal oblique T1FS MR arthrogram shows tear of the anterior inferior labrum as part of the ALPSA lesion. This is the same view as seen on the right during arthroscopy.

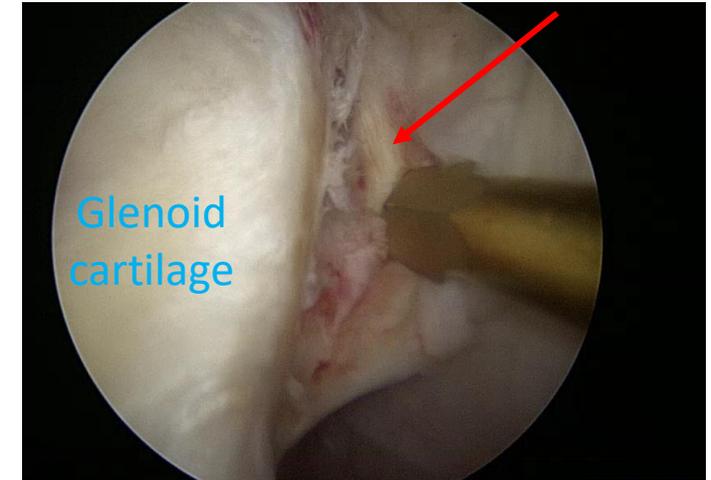
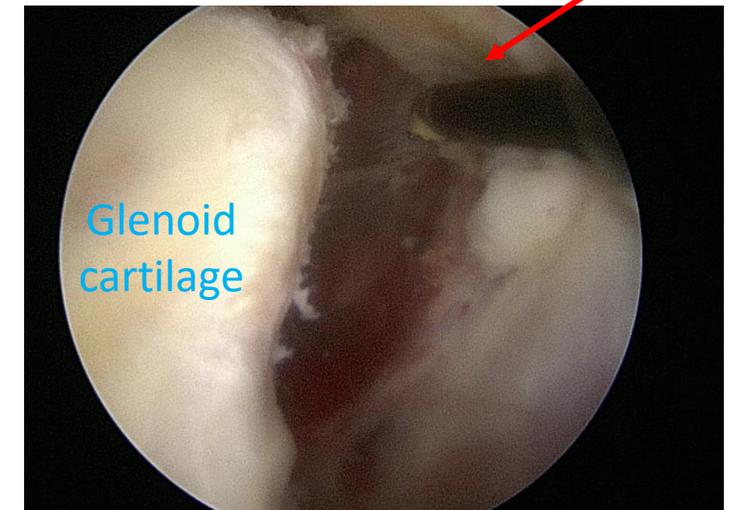
Probe pulls back tear further to show the periosteum is medially stripped

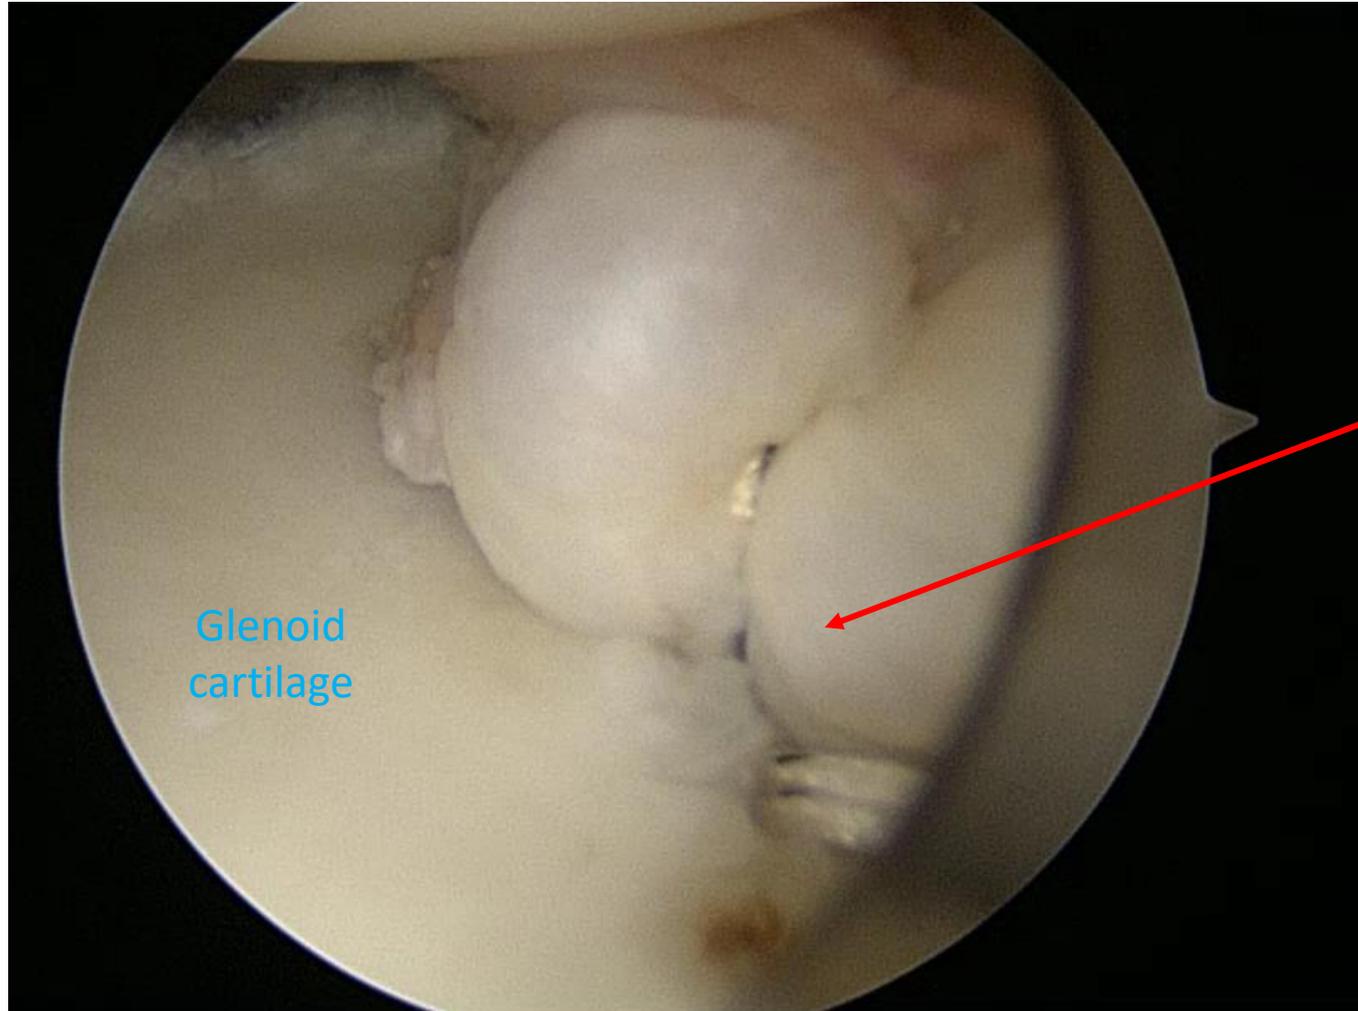
Repaired anterior inferior labroligamentous complex. Sutures hold these structures down at their anatomic locations.

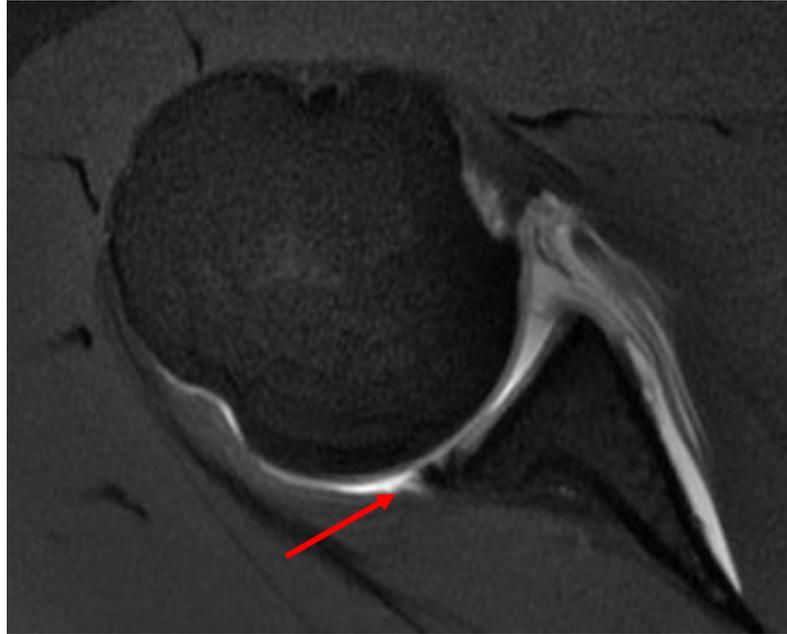
Axial T1FS MR arthrogram shows fraying of the direct posterior labrum

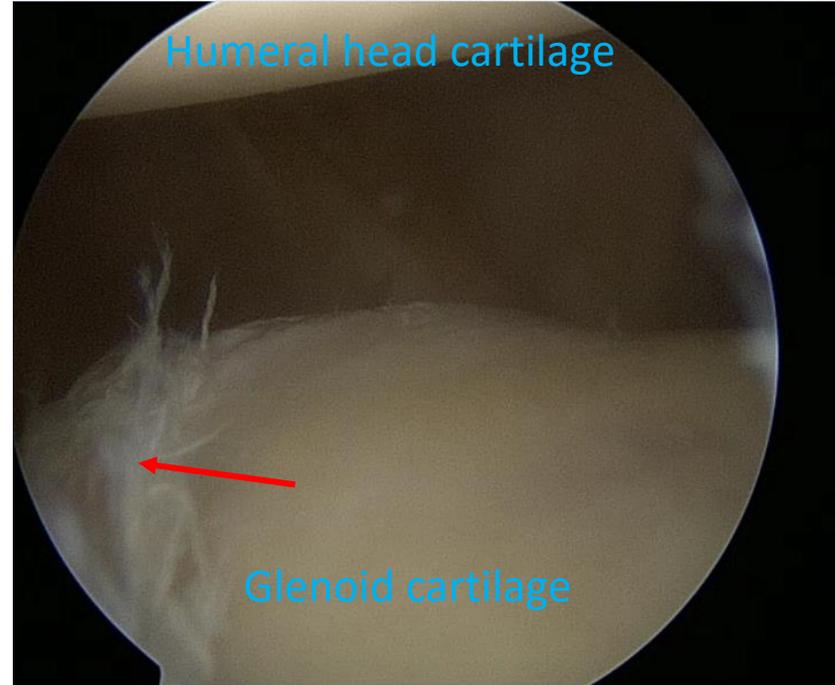
Arthroscopy shows fraying of the direct posterior labrum (which was debrided at the time of surgery)

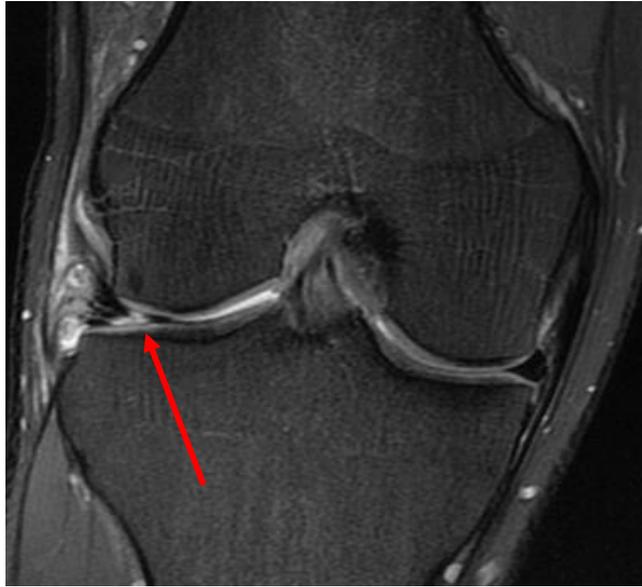
Coronal PDFS MR shows a complex tear of the lateral meniscus

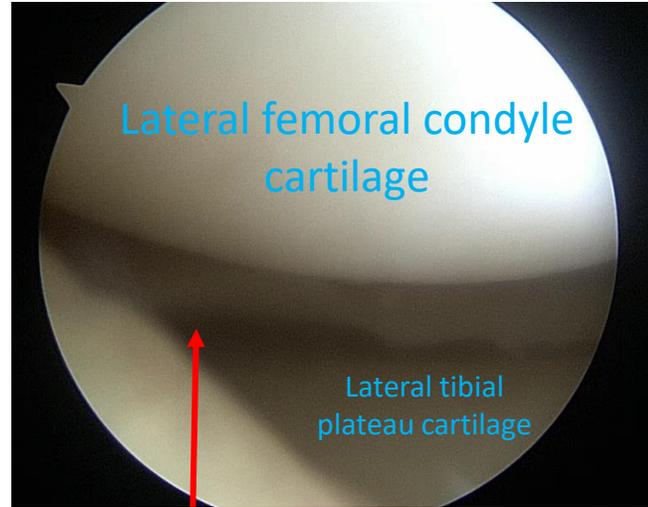
Lateral meniscus tear (blurry image without video to show how probe pulls apart tear, sorry!)

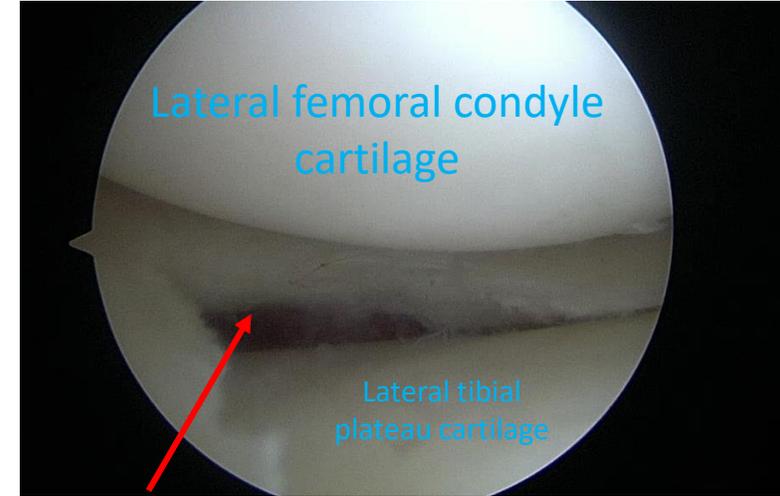
Lateral meniscus tear debrided down to clean margins

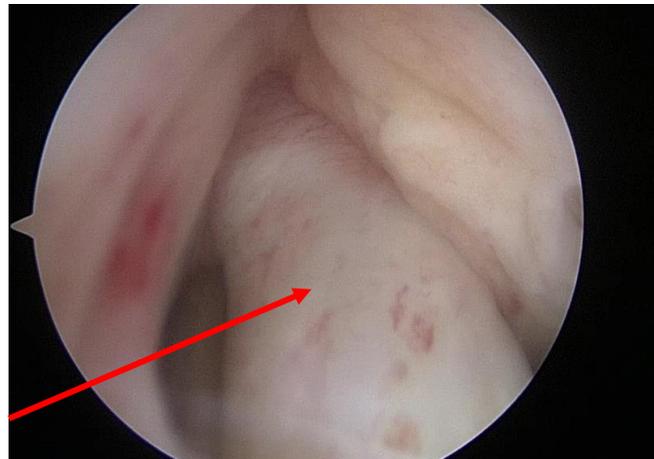
Intact ACL in the notch

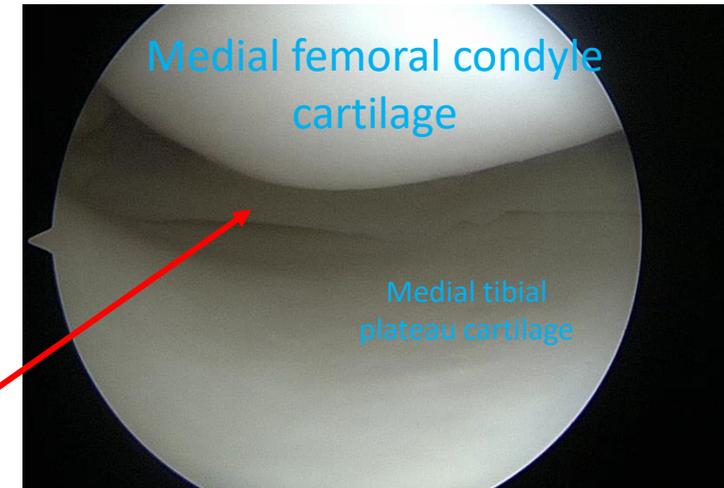
Intact medial meniscus

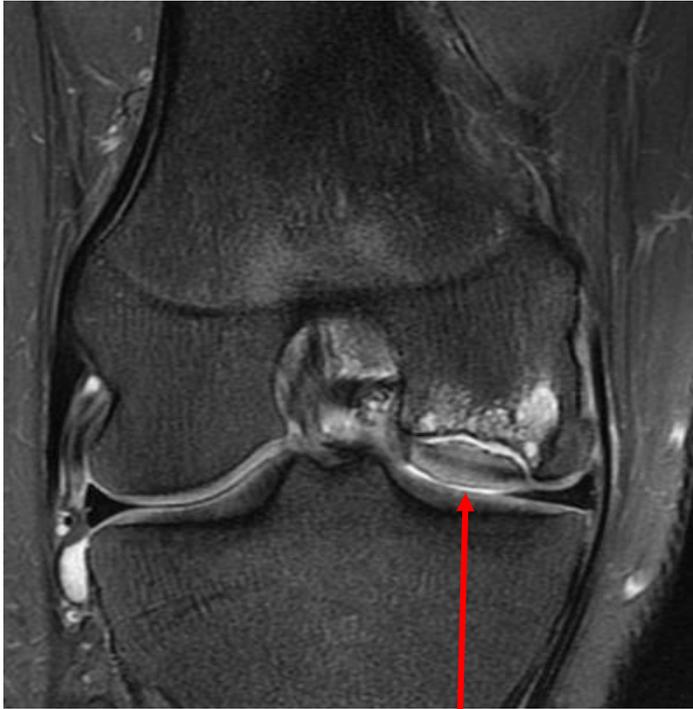
Coronal PDFS MR shows a large osteochondral lesion in the medial femoral condyle undermined by fluid. This was found to have a thin intact cartilage cover at surgery and the cysts below were debrided, bone graft was placed between the sides of the defect and the defect was secured with screws

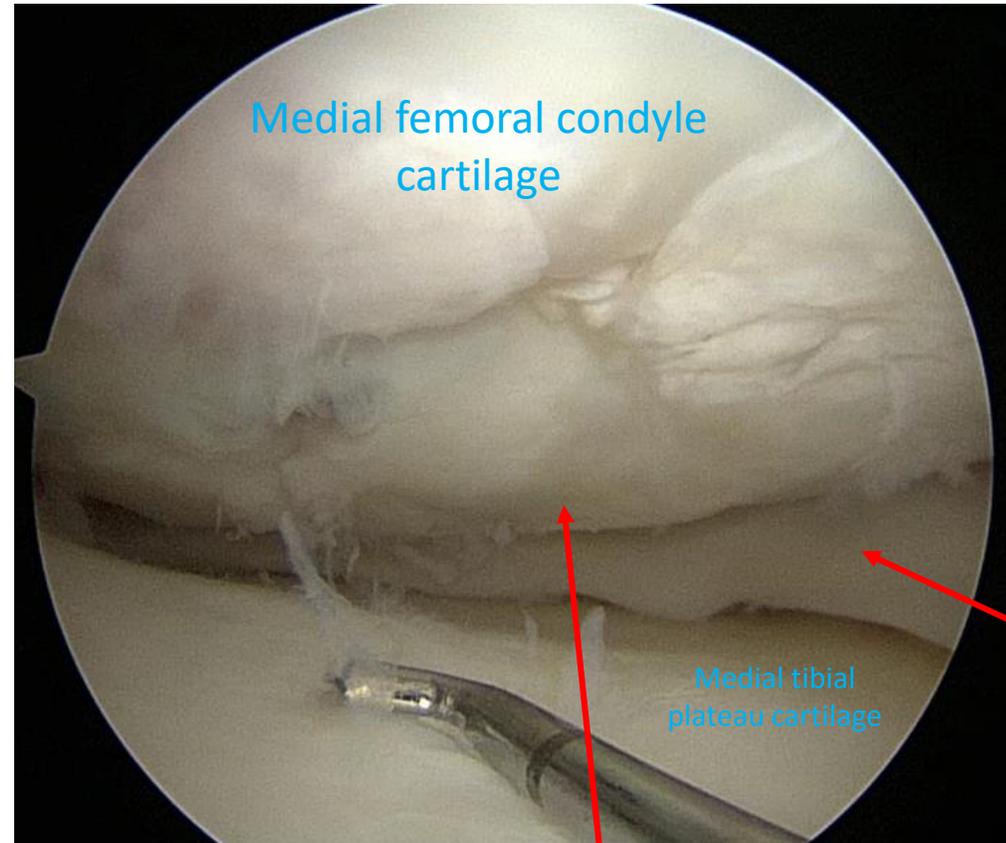
Medial femoral condyle cartilage

Medial tibial plateau cartilage

Medial meniscus

At arthroscopy, the healed OCL appeared stable including with probing.

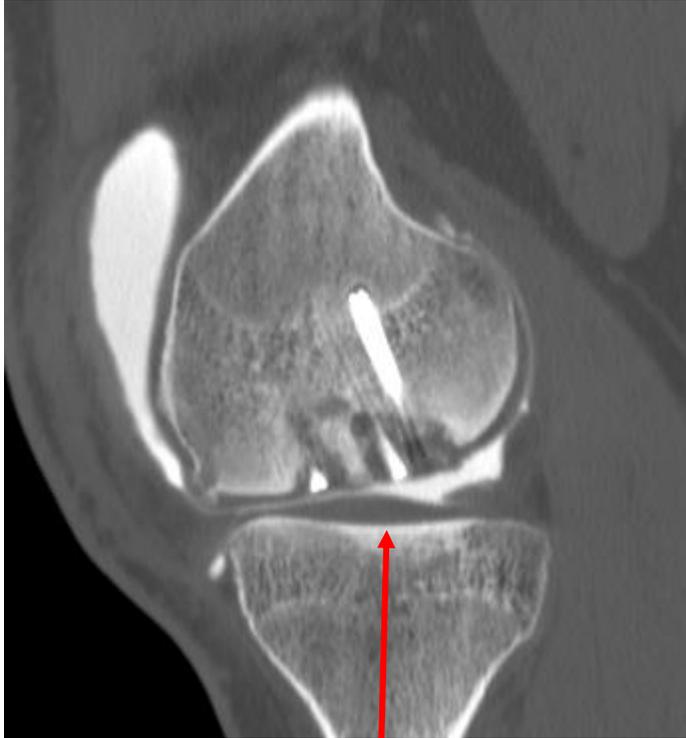
Sagittal CT arthrogram confirms stability as no contrast got into the OCL. Screws were not proud but were tightened.

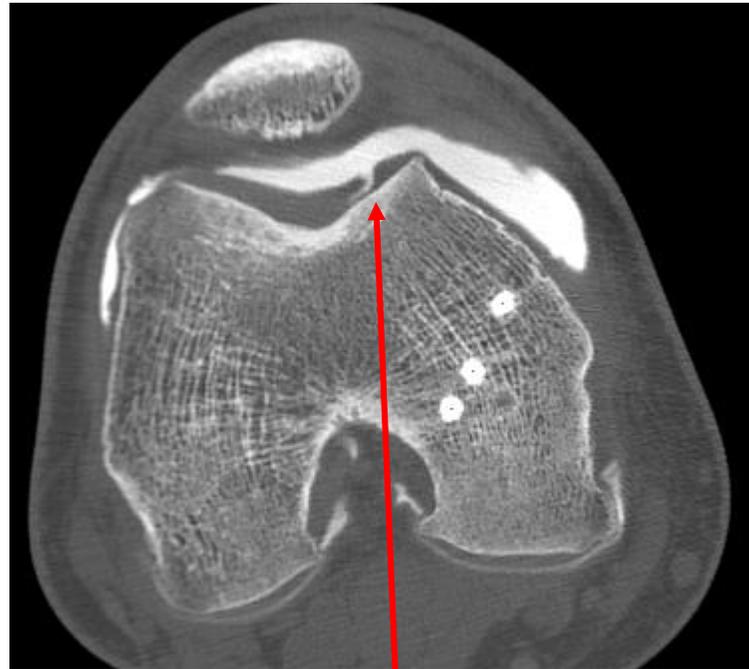
There was a grade 4 defect in the medial trochlea however.

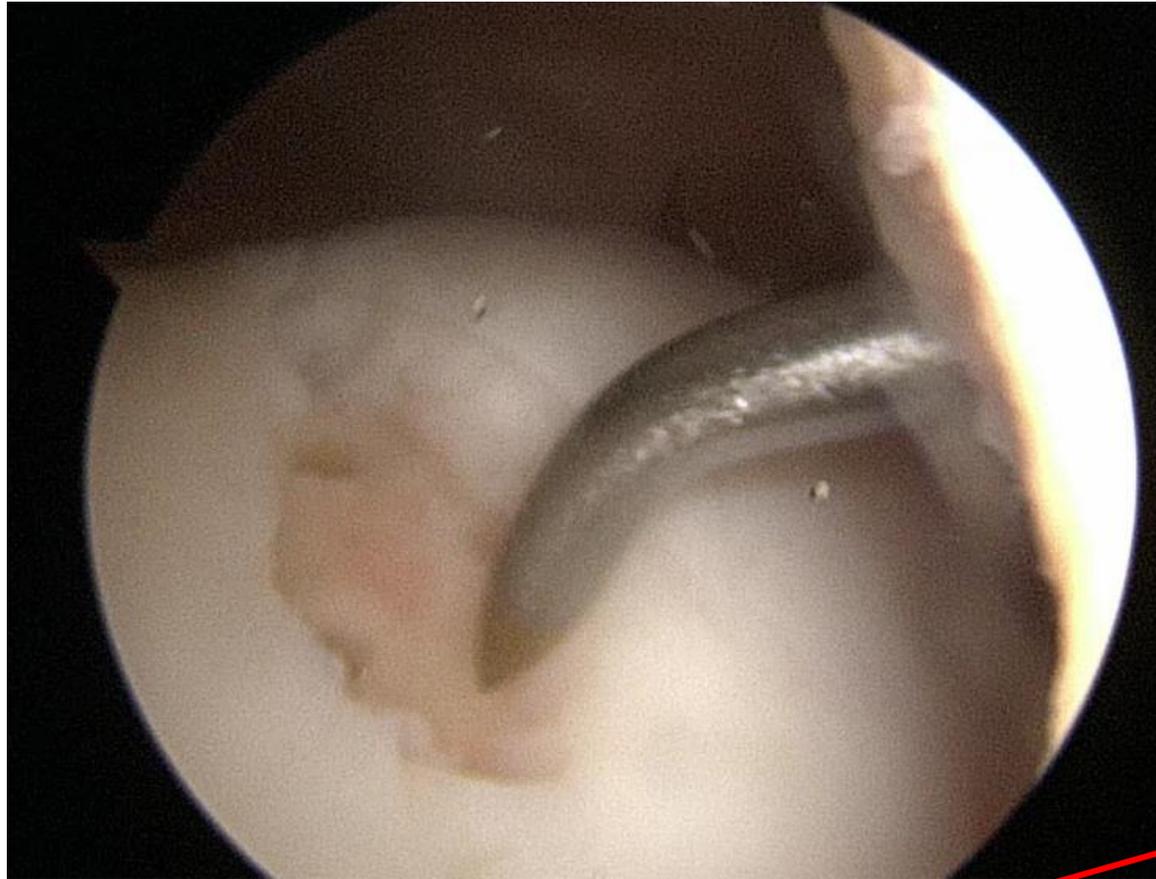
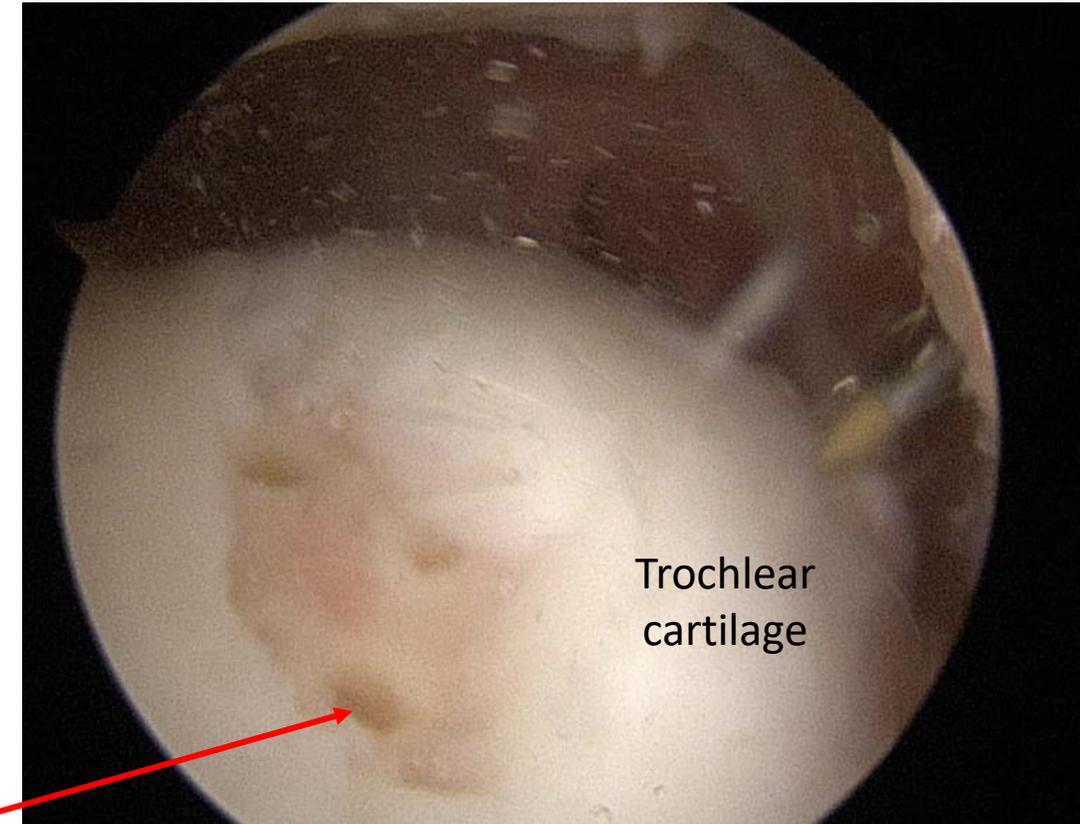
The defect was debrided to a clean base to prevent further delamination and then the subchondral plate was microfractured (holes were poked) to elicit bleeding into the defect with the hopes that factors in the marrow will promote healing

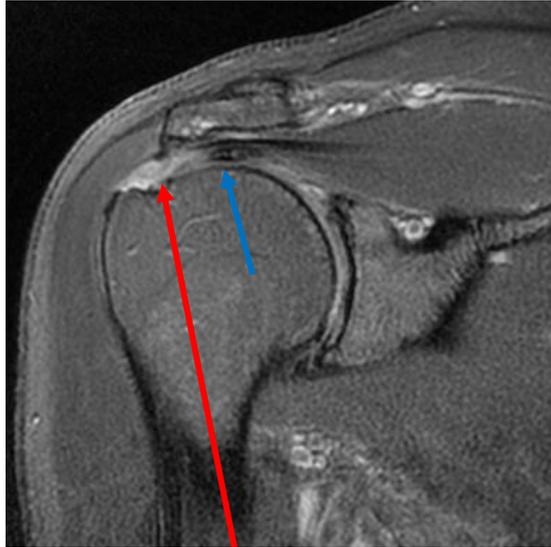
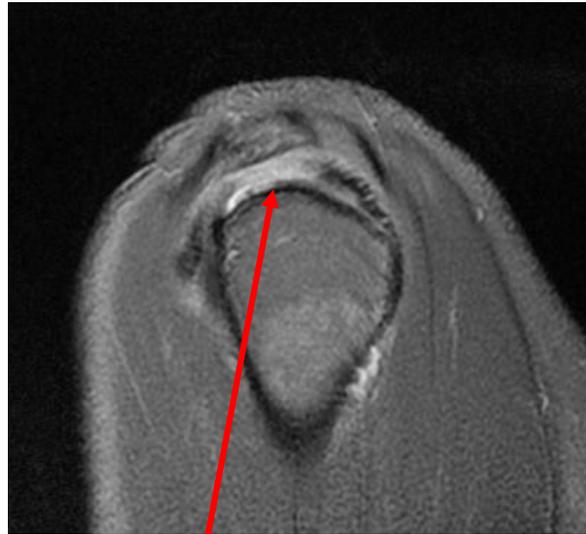
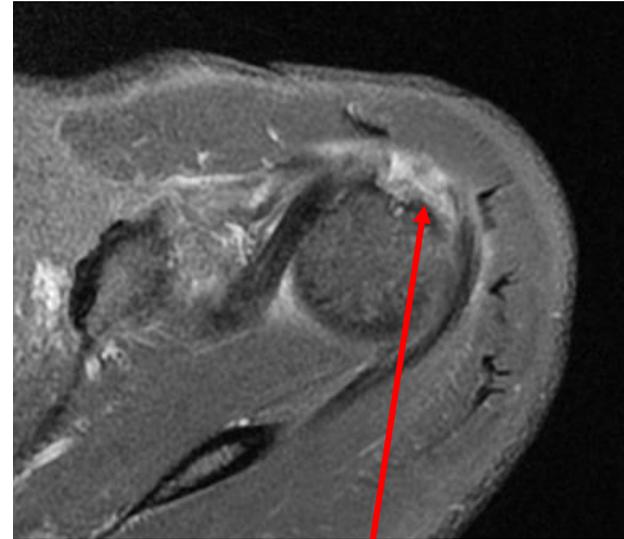
Coronal, sagittal oblique and axial PDFS MR shows a full thickness tear of the supraspinatus beginning at the anterior leading edge and propogating posteriorly to the level of the conjoined tendon. Notice the thickened rotator cable (blue arrow).

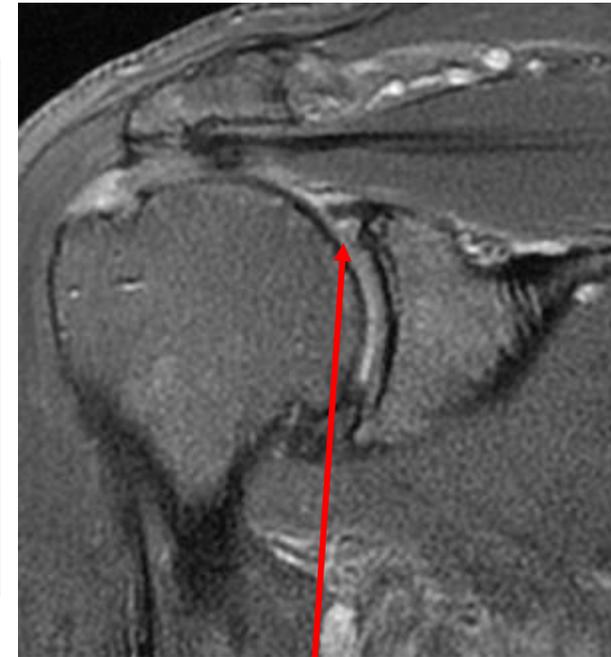
Coronal PDFS MR shows a tear of the labrum from anterior superior to posterior superior (all slices not shown), SLAP lesion.

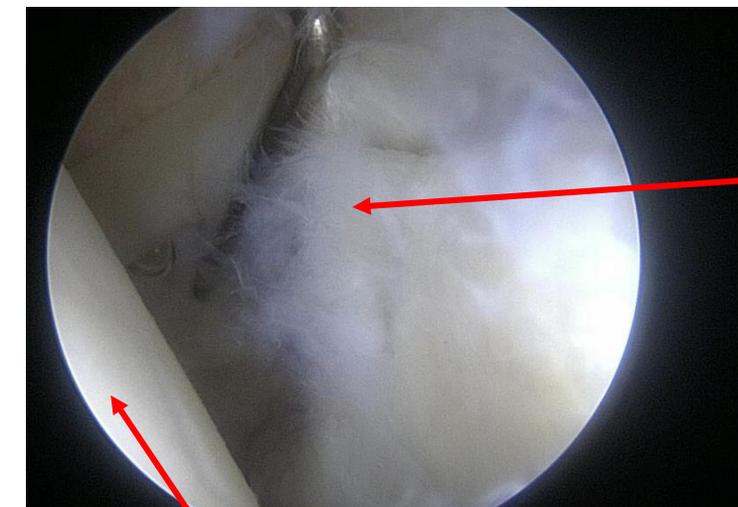
Humeral head cartilage

Top left shows probe pulling up long head of the biceps tendon as it comes to the anchor. The labrum is frayed and degenerated.

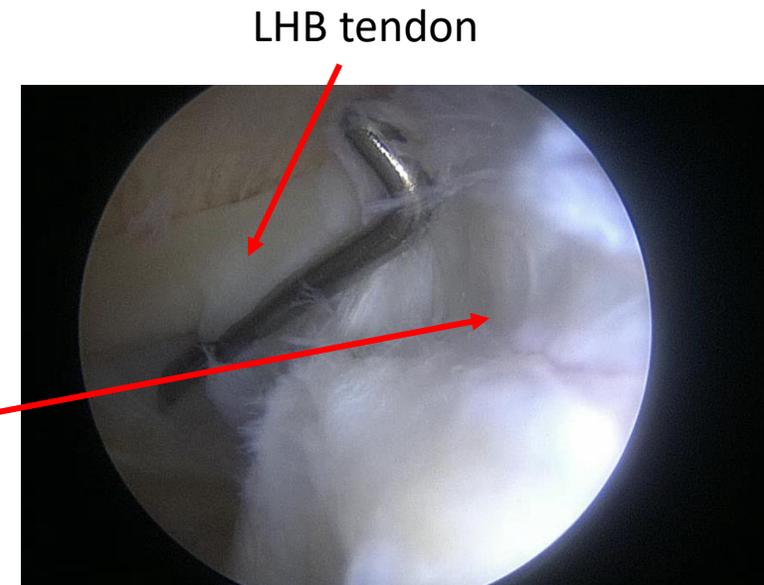
LHB tendon

Top right shows probe pulls up LHB tendon which separates from the labrum due to the SLAP.

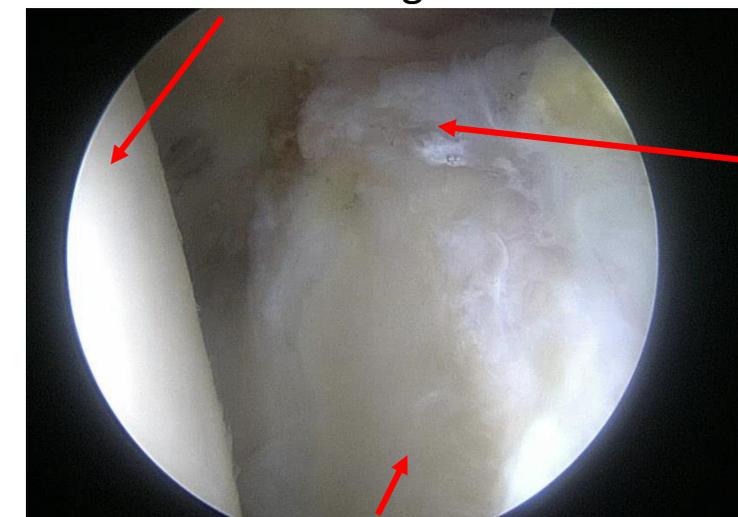
Glenoid cartilage

Bottom left, the LHB has been released and the labrum debrided.

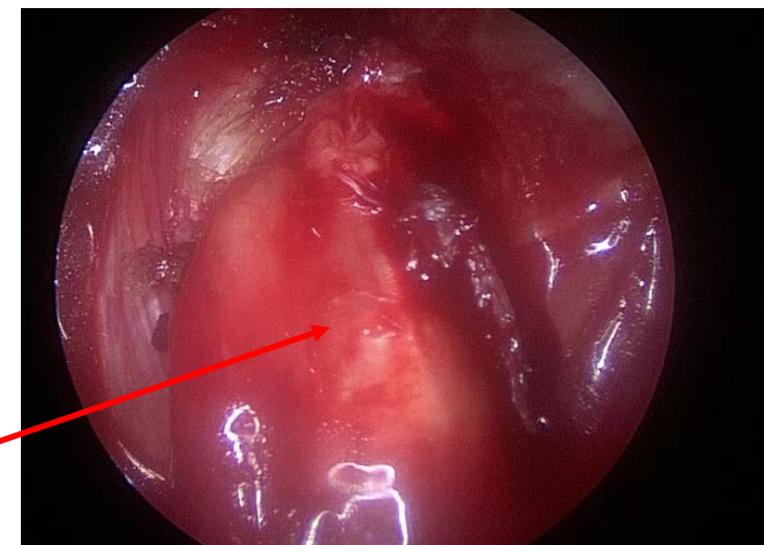
Bottom right, the released biceps tendon is anchored down in the humerus outside of the joint as part of a biceps tenodesis.

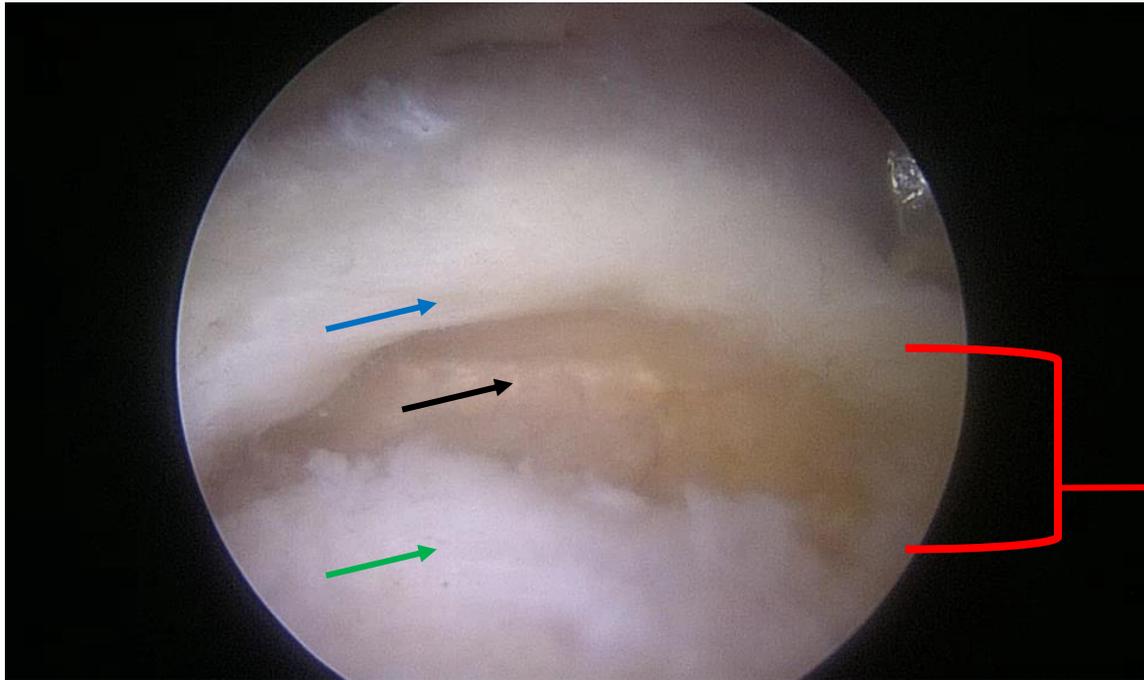
From inside the joint and looking cranially, the tear of the supraspinatus tendon is seen as is the rotator cable (blue arrow) to which the tear has retracted. Lateral tendon stump is also seen (green arrow). Through the tear and from inside the joint, the subacromial bursa can be seen (black arrow). This is why full thickness tears allow for fluid to migrate from the joint into the SA/SD bursa.

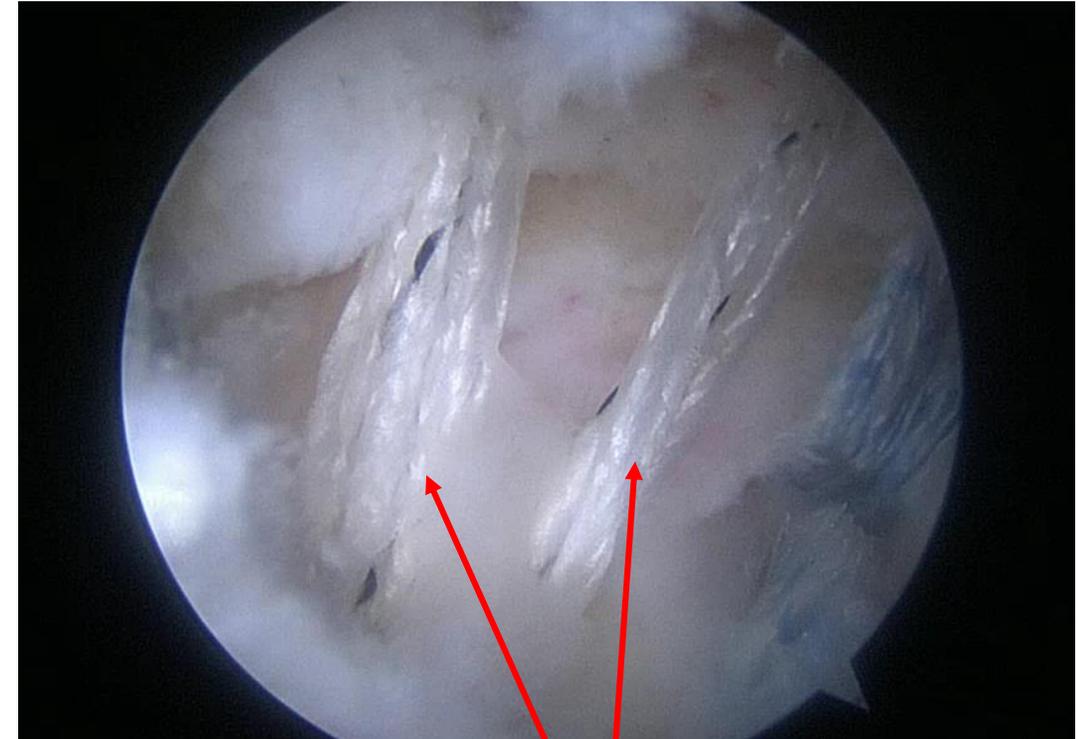
The tear is brought laterally toward the footprint and the bone is prepared. Then suture anchors are used to secure the torn tendon back to the foot print.
